## Memo

RE: South Dayton Dump, Valley Asphalt reconnaissance brief

### Introduction

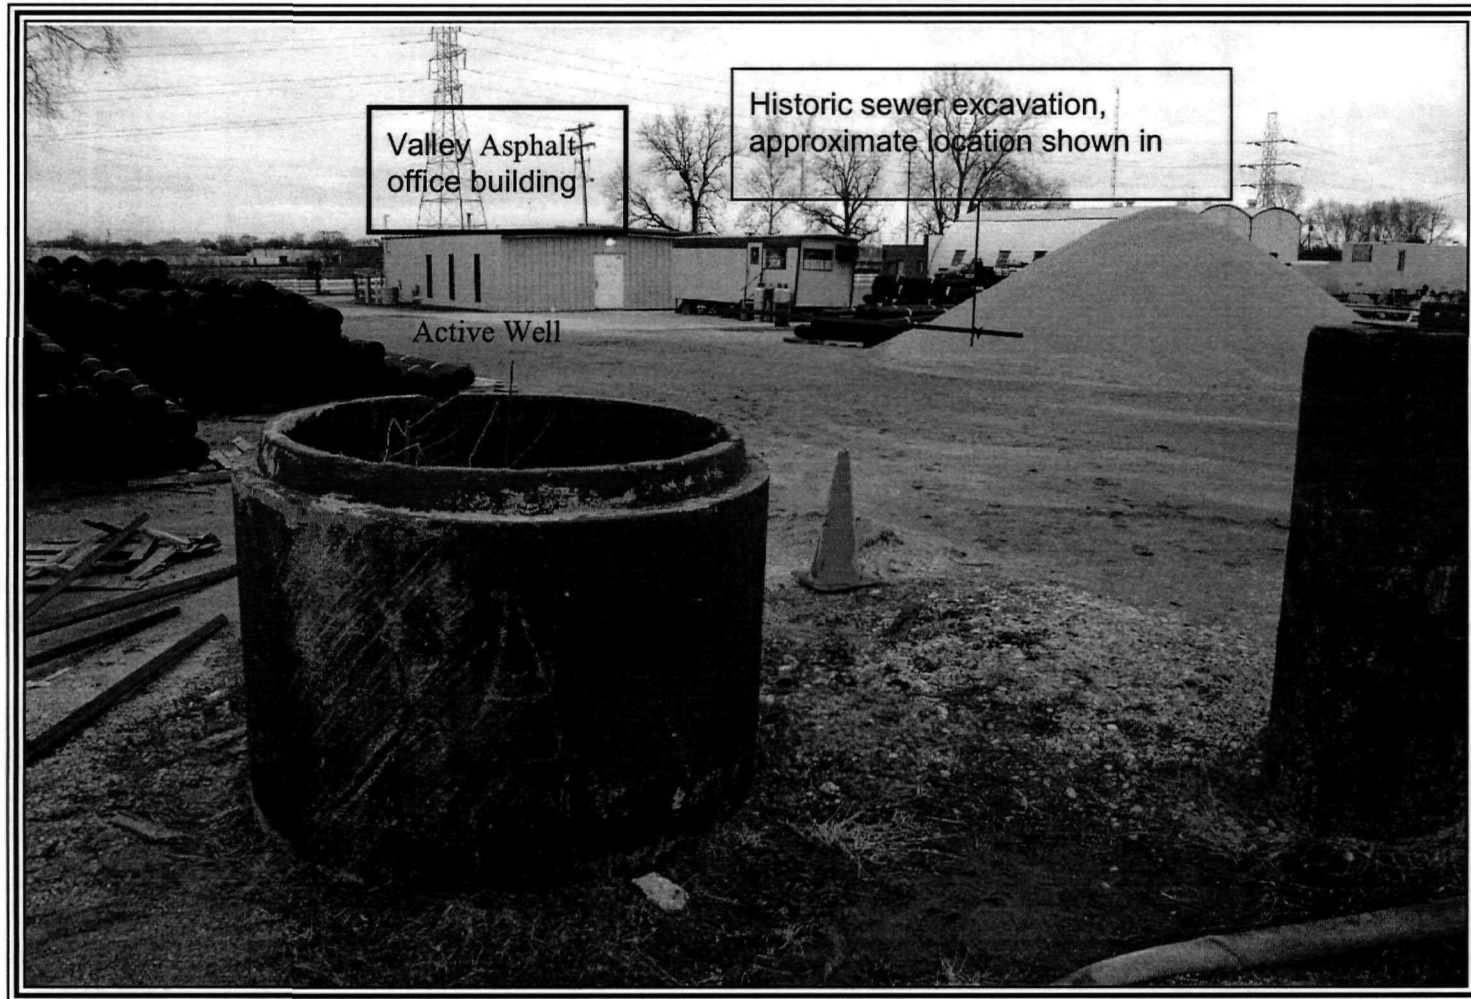
Ohio EPA Photograph 1: Valley Asphalt facing northeast.

Date Photographed: January 20, 2006. Great Miami River located in background beyond white fence.

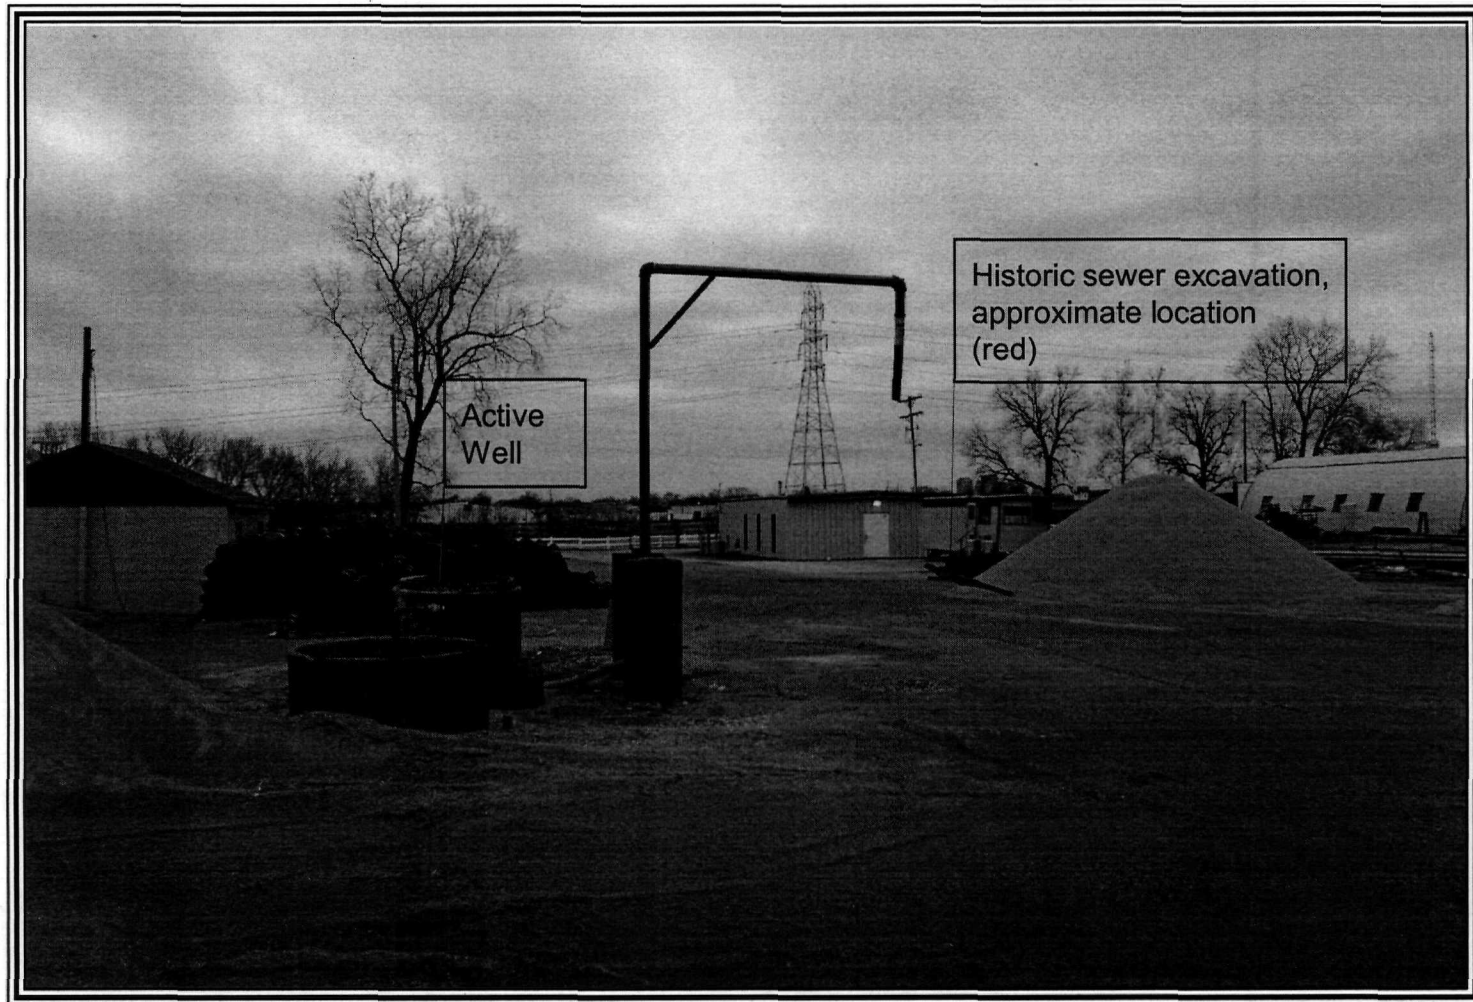
Ohio EPA Photograph 2: Valley Asphalt facing north.

Date Photographed: January 20, 2006. Great Miami River is located beyond white rail fence.

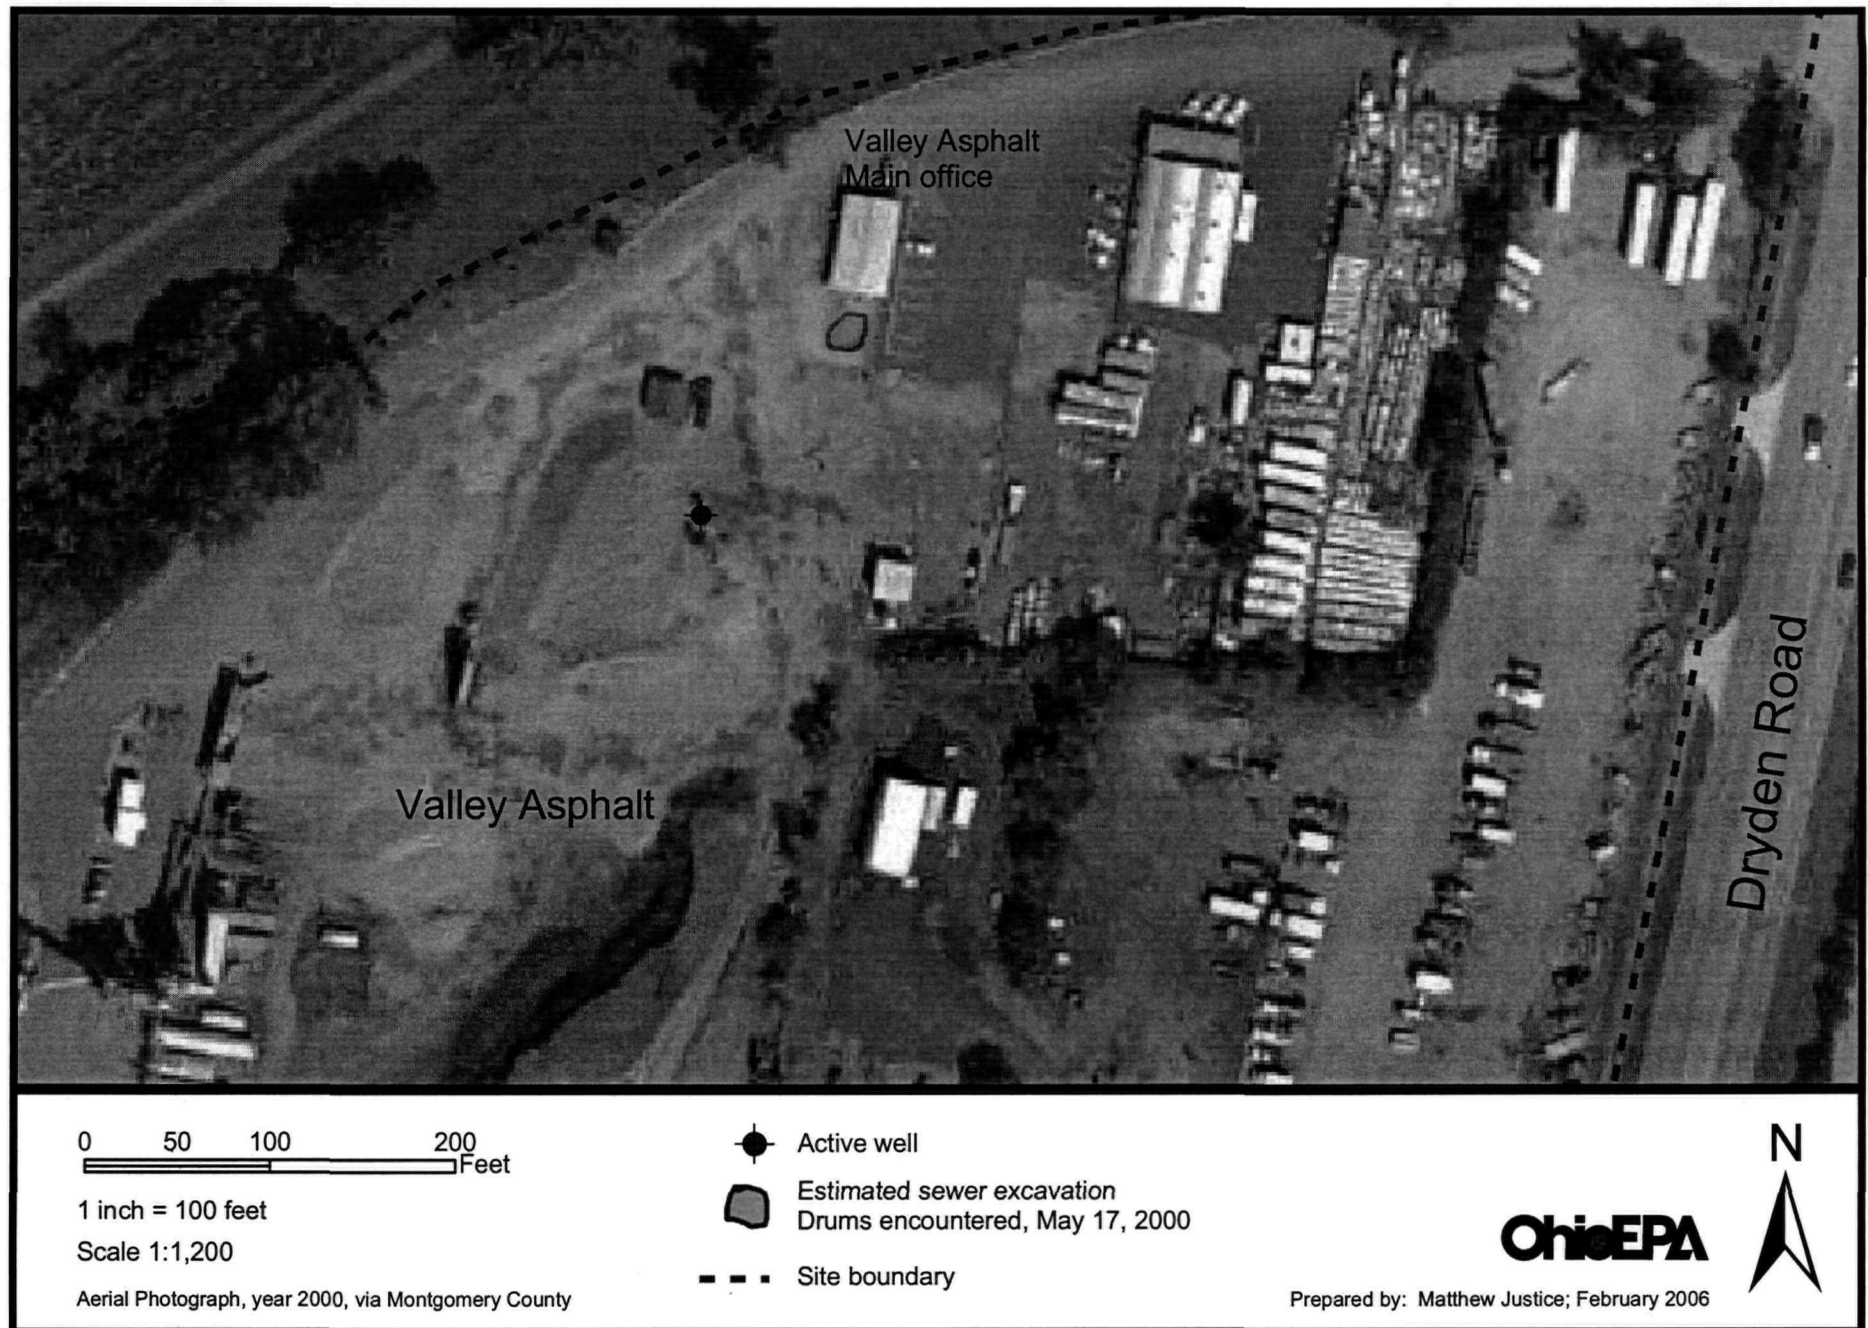
South Dayton Dump Site  
Moraine, Ohio  
Montgomery County

The enclosed maps prepared by Ohio EPA locate the excavation site in both local and regional scale view in relation to the Site boundary. The maps highlight the location's presence in the northern portion of the Valley Asphalt property, south of the main office building.
